PHASE I ARCHEOLOGICAL INVESTIGATION
PROPOSED KATE MULLANY PARK
KATE MULLANY HOUSE NATIONAL HISTORIC SITE
(98NR01334)
350 EIGHTH STREET
CITY OF TROY
RENSSELAER COUNTY, NEW YORK

HAA 3992-21
OPRHP 06PR00447

JANUARY 2008

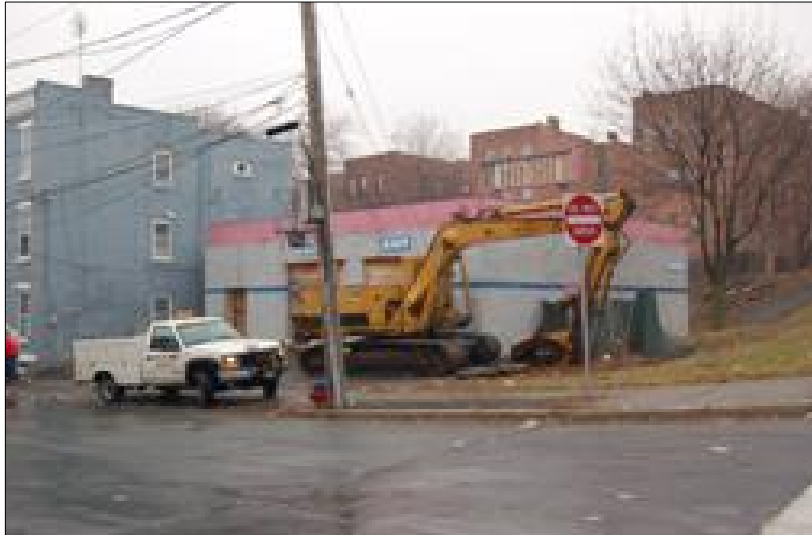
Figure 1. View northeast of the northeast corner of Hoosick and Eighth Street and the Quick Lube shop south of 350 Eighth Street before it was razed in 2005 (ALSC 2008).

The area south of Hoosick Street was until recently a modern Quick Lube auto maintenance shop (Fig. 1, Map 2, Photo 2). The property was purchased by the ALSC in 2005 and the building was razed and removed shortly thereafter. According to Paul Cole, the Executive Director of the ALSC, the shop had a full basement that was probably 8 or 9 feet tall where the mechanics worked under the vehicles. Some of the debris from the demolition was used to fill the basement hole after the demolition. Asphalt paving extended from Eighth Street to the front (west) side of the building. The asphalt driveway that extends from Ninth Street in the southeast corner of the site (Map 2, Photo 2) extended to an asphalt paved area on the back (east) side of the shop building. This area has likely been very disturbed by the construction and later demolition of the building.

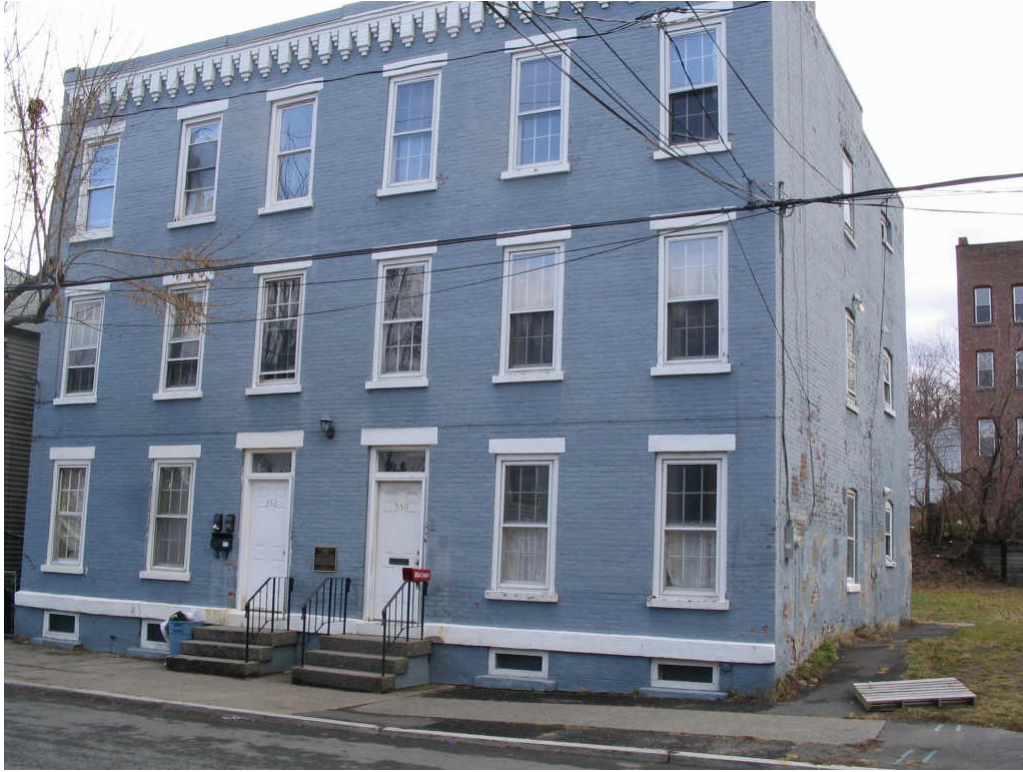
Photo 1. View northeast of the front (west) side of 350 and 352 Eighth Street. The asphalt walkway along the south side of the building will be removed and replaced with plantings. Trees will also be planted along Eight Street in front of the house.

The project map (Map 2) and Photos 1-6 depict the modern condition of the Kate Mullany House site. The only extant buildings in the project area are 350 and 352 Eighth Street (Photo 1). The widening of Hoosick Street in the late 20th century covered over the footprints of the six buildings shown facing the street on the 1885 and 1903 maps (Map 8 and 9). A great amount of filling and grading likely took place to change the road from a two lane street to a six-lane major roadway, which created the slope along the western edge of the site (Photos 2 and 3)

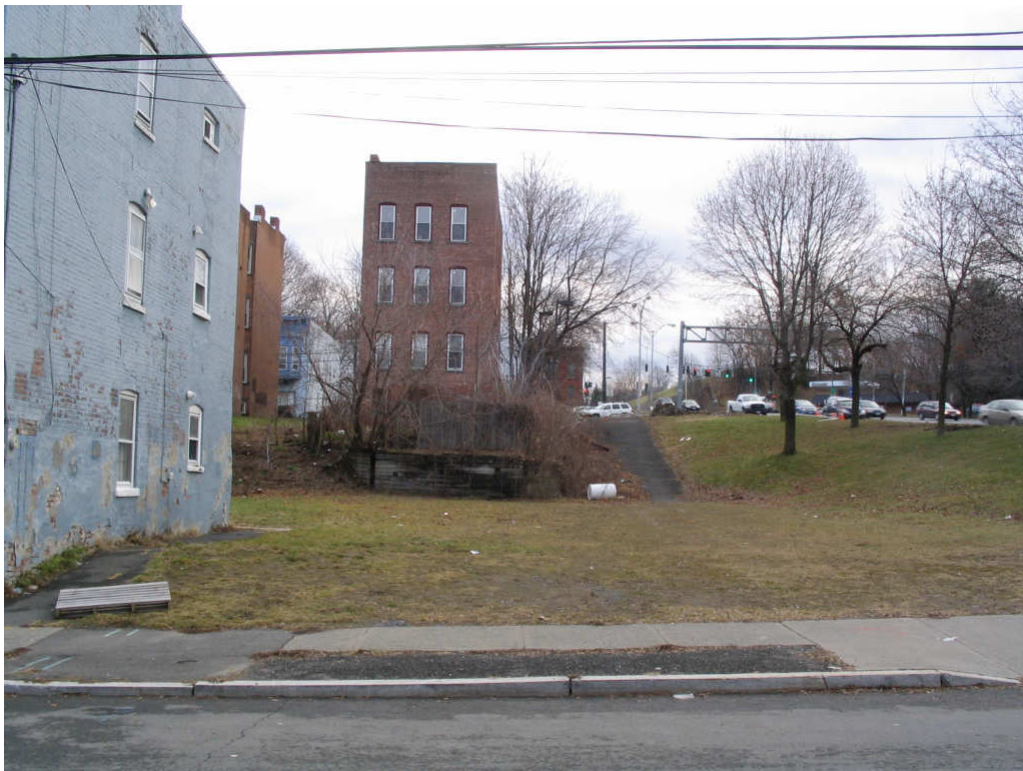
Photo 2. View east of the empty lot south of 350 Eighth Street where the Quick Lube formerly stood (see Fig. 1). This area was disturbed by the construction and later demolition and removal of the Quick Lube building. The asphalt driveway that extends from the empty lot to Ninth Street will be removed and replaced with grass and trees.

A proposed parking area and street side gathering space (A, B, and H on Map 3) will be constructed in the vacant lot south of 350 Eighth Street (Photos 2 and 5). The vacant lot south of 350 Eighth Street was until recently a Quick Lube automotive maintenance shop, which has been razed and all of the debris removed from the property (see Fig. 1 above). This area has been likely disturbed by the construction and later removal of the shop. The NPS recommended no testing in these areas. HAA, Inc. did not conduct any testing in these areas.

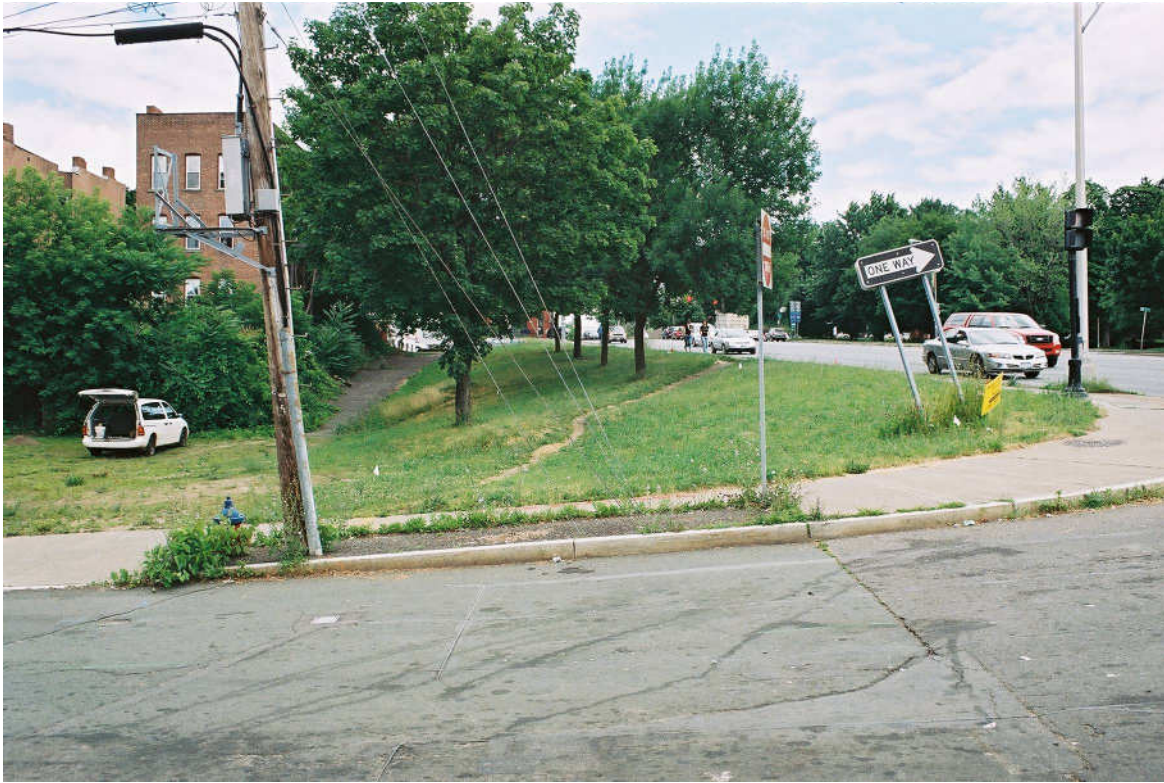
Photo 3. View east of the slope along the south edge of the project area. Hoosick Street/ NY Route 7 is in the right side of the photo. This part of the project area was filled when Hoosick Street was widened from a two-lane street to a six-lane roadway in the second half of the 20th century.

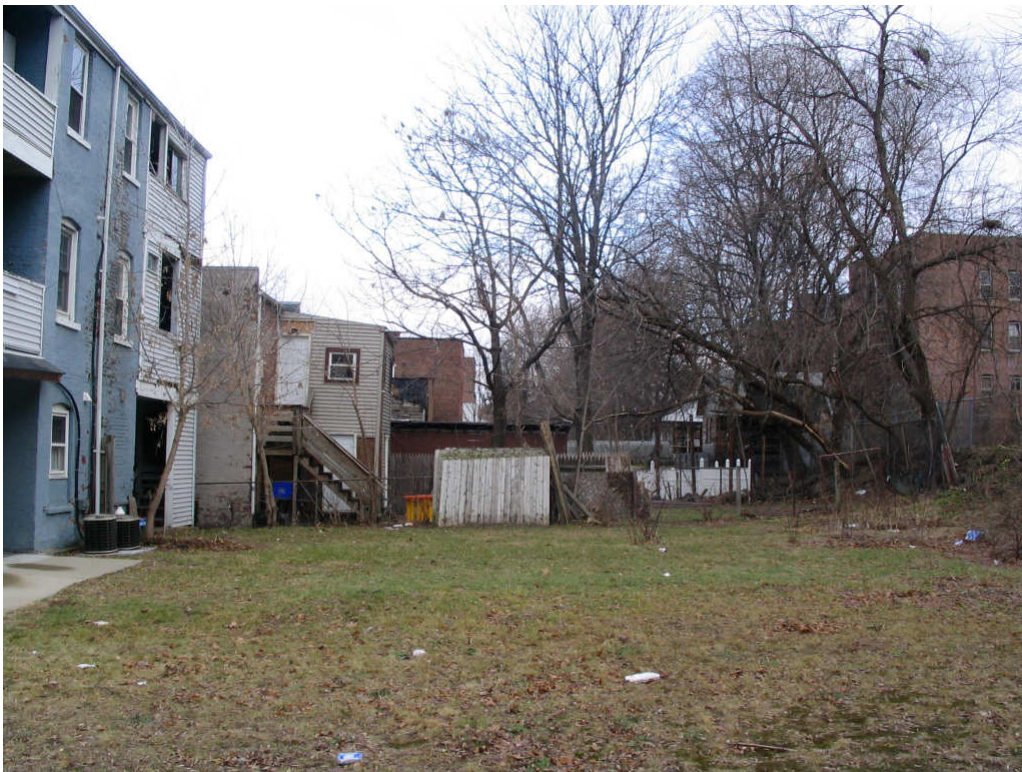
Photo 4. View north of the backyard of 350/352 Eighth Street. It is relatively flat with a steep, weedy slope to the east.

Impacts in the backyard include a fence to be installed around the perimeter of the backyard of 350/352 Eighth Street, removal of an overgrown tree on the back wall of the building (Photos 4-6), a drainage swale will be constructed along the back property line (Photo 7), and possible grading of the backyard to direct drainage away from the house. A seating area, garden, and storage shed will be constructed behind 350 Eighth Street and the lawn area behind 352 Eighth Street will be maintained (G on Map 3).

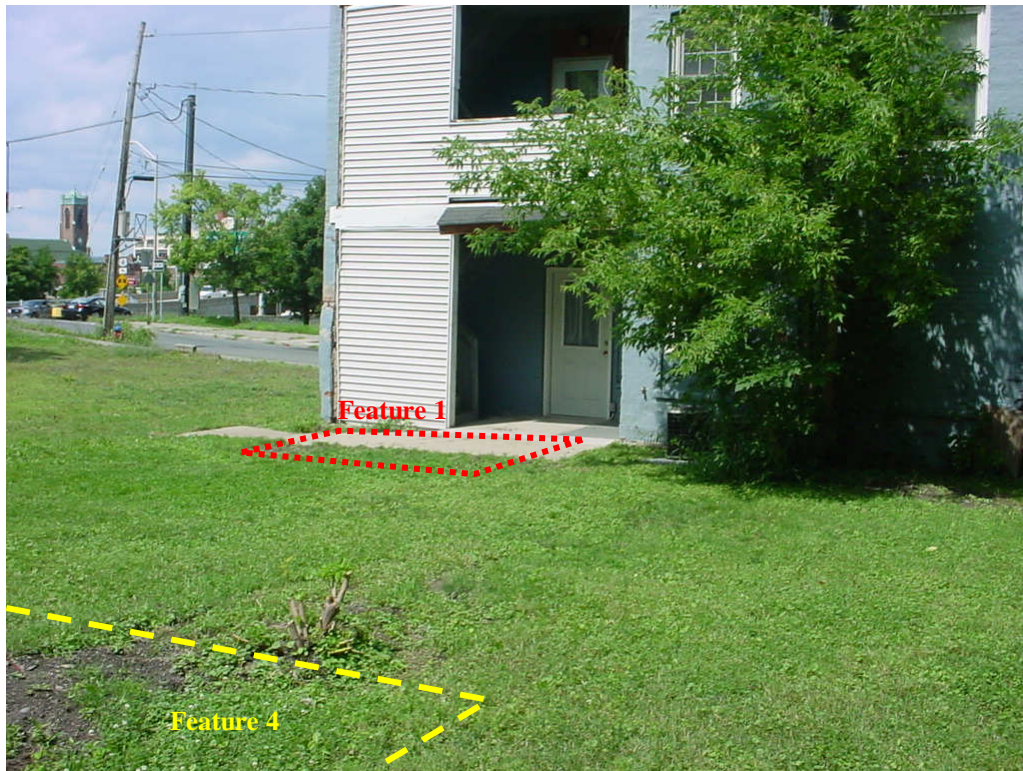
Photo 5. View southwest of the rear of 352 Eighth Street and the vacant lot to the south of the building that was recently a Quick Lube car repair shop. The privy (Feature 4) is located near the bush stump in the foreground.

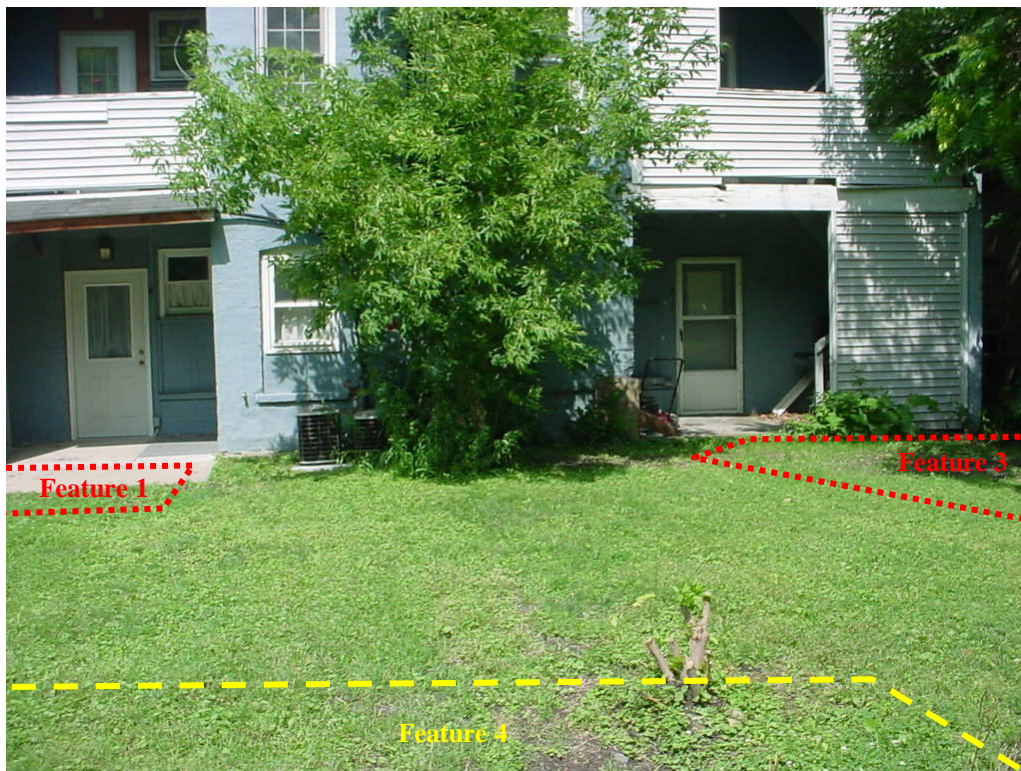
Photo 6. View northwest at the former location of the outbuilding behind 350/352 Eighth Street on the 1903 Sanborn that was found by the NPS resistance survey. This location was also marked by a small depression in the ground surface, which is only slightly visible in the foreground of this photograph, with a bush growing out of it, of which only the stump remains in the foreground. Feature 4 was identified just east of where the bush stump is located. The Kate Mullany House at 352 Eight Street is the blue painted brick building on the left and 350 Eighth Street is the light colored vinyl-sided building on the right.

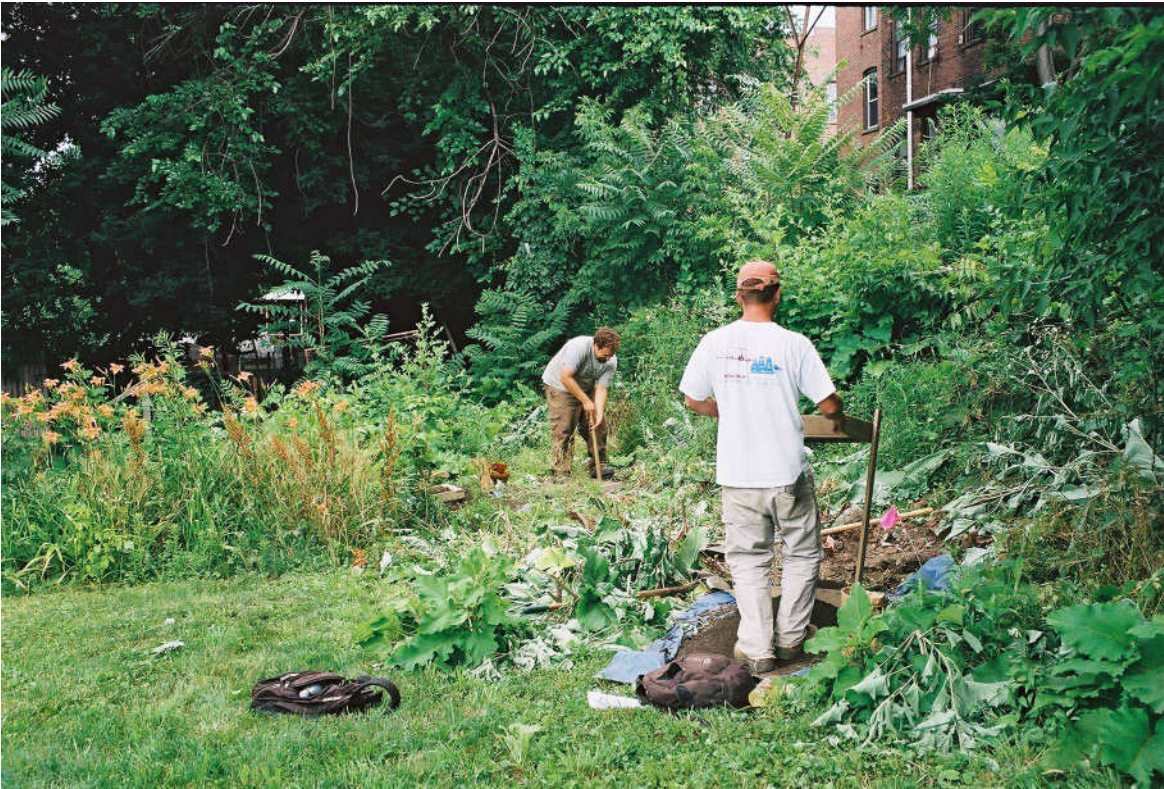
Photo 7. View north of the eastern edge of the backyard of 350/352 Eighth Street. A slope rises to the east adjacent to the property line here. A new retaining wall is proposed to holdback the slope. Excavation in this area encountered deep fill that may be associated with historical landscape alterations that took place around the 1860s - 1870s when Eight, Ninth, and Tenth Streets were extended north of Hoosick Street (also see Maps 6-7).

The NPS recommended excavating 50 by 50 cm (20 in by 20 inch) test pits placed at 5-meter intervals around the perimeter of the backyard to test for the proposed fence installation. Units 1 through 11 were 50 by 50 cm (20 in by 20 inch) test pits excavated around the perimeter of the backyard (Photo 7 and 8).

Eleven 50 by 50 cm (20 by 20 inches) units were excavated at maximum 5-meter (16.4 ft) intervals around the perimeter of the backyard (Photos 7 and 8) to test the APE for the proposed backyard perimeter fence. In addition, 19.5 square meters (210 square feet) of minimum 50-cm (20 inch) wide slit trenches (STs) were dispersed throughout the yard (Table 3), to evaluate archeological features encountered in the test units and investigate the anomalies identified by the National Parks Service's geophysical survey of the yard.

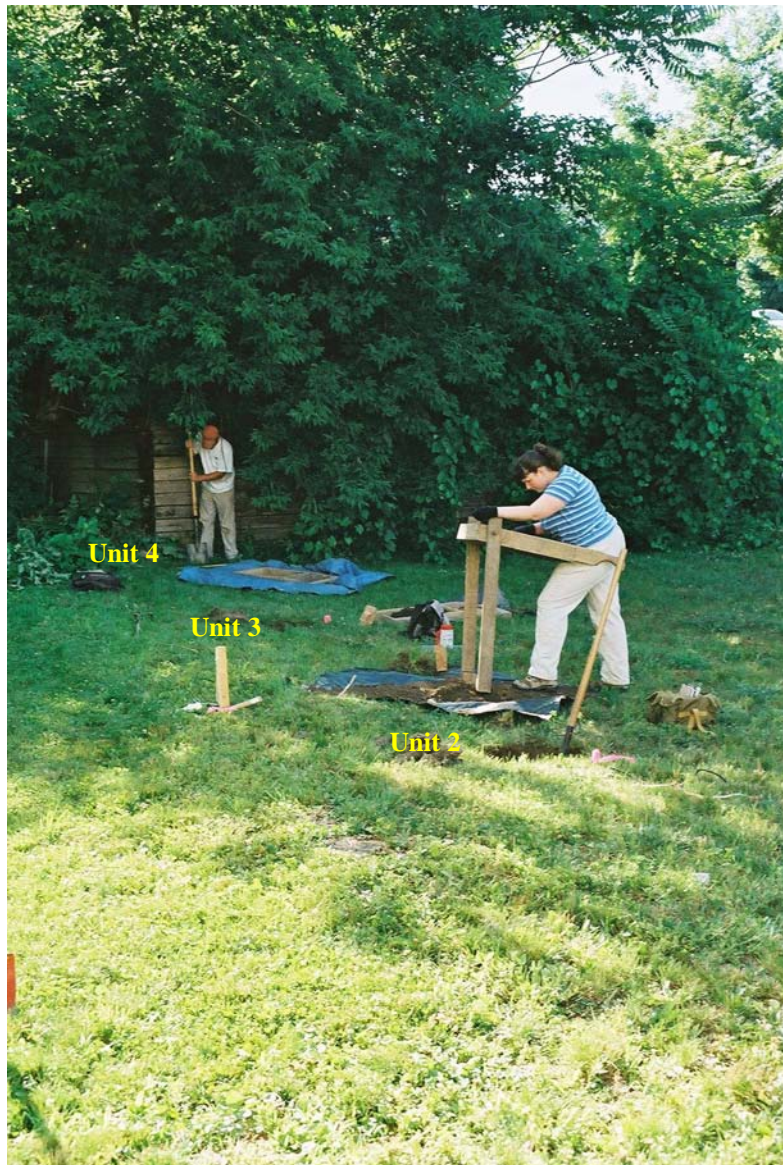
Photo 8. View southeast of the southeast corner of the backyard area of 352 Eighth Street. Units 2 and 4 are being excavated. A portion of a modern retaining wall is visible behind the archeologist at Unit 4.

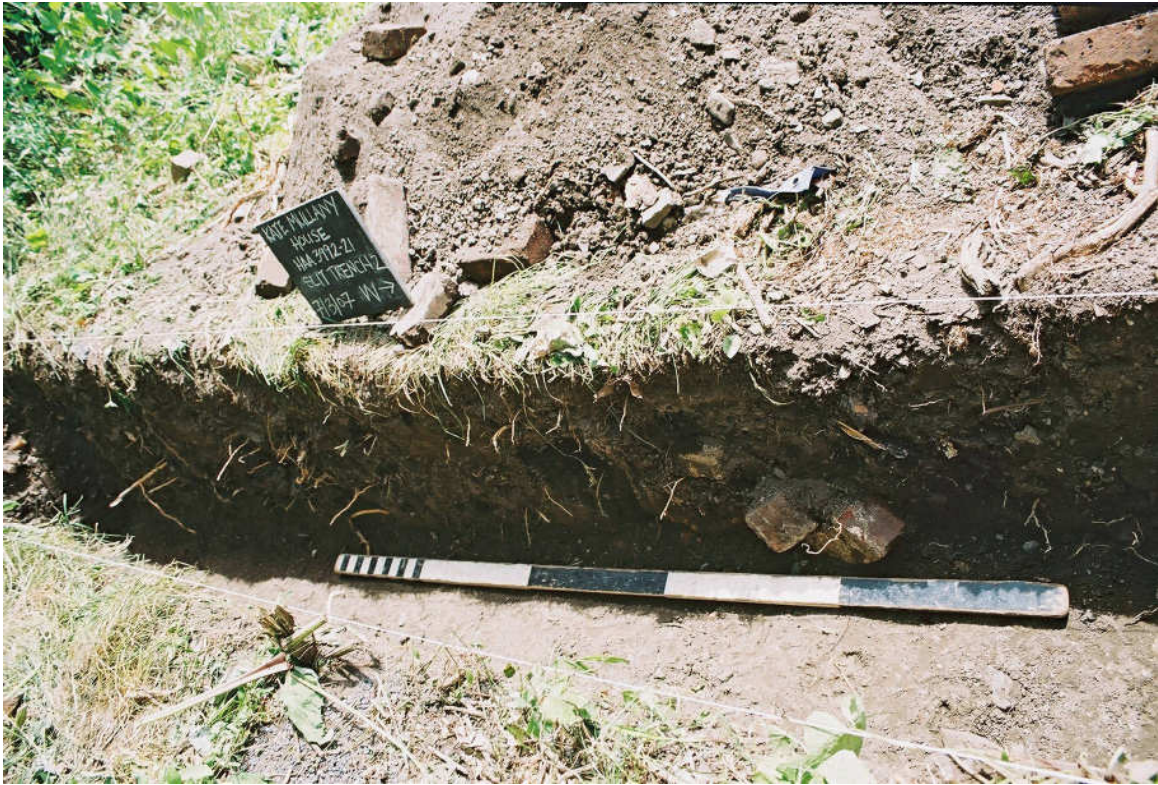
Photo 9. View southeast of the south wall of ST 2. This trench was excavated to investigate an anomaly detected in the NPS geophysical survey. No features were identified. The anomaly was likely a large rodent burrow that was uncovered here.

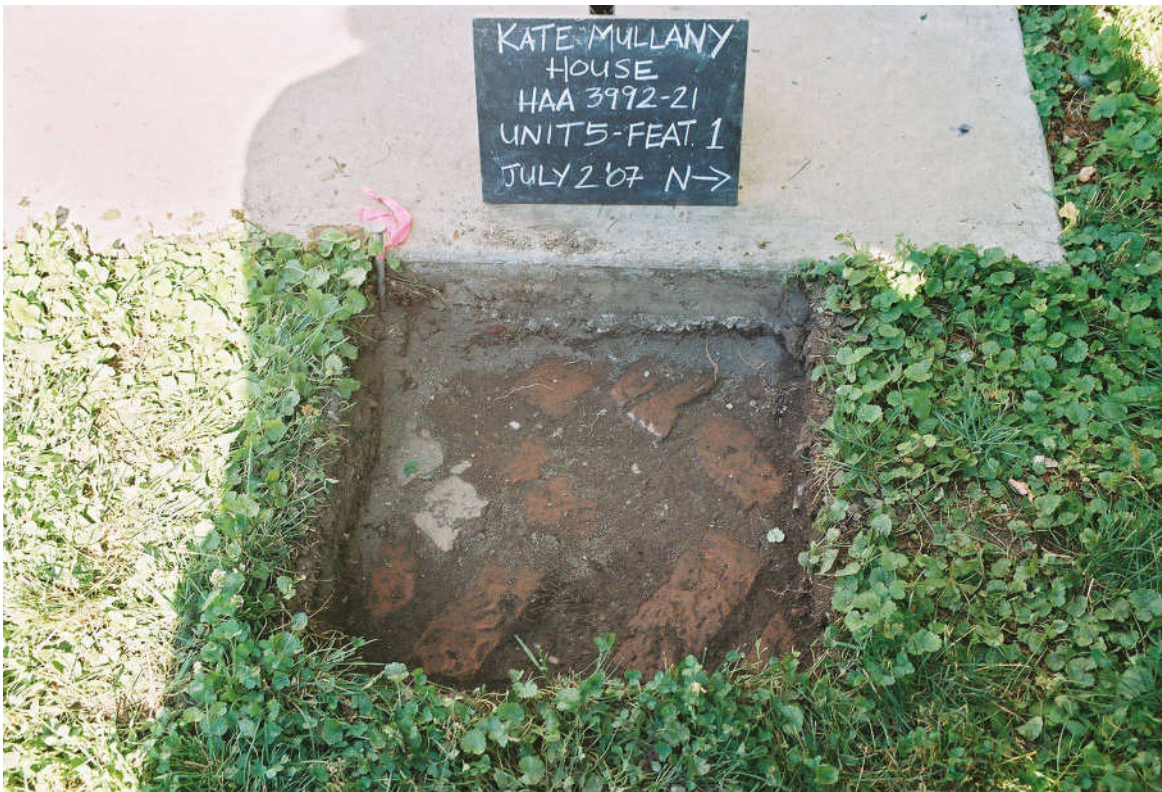
Photo 10. View west of Feature 1 in Unit 5. The historic brick-paved surface extends beneath the modern concrete patio.

The bricks were laid without mortar on their broad sides. There was a somewhat discernable pattern to the laid bricks in Feature 1. The southern portion appeared to have a diagonal running bond-type pattern (bricks laid end to end in overlapping, parallel rows) that transitioned into a herringbone pattern in the northern portion. Some of the bricks appeared to be broken or only partial. None of the bricks were marked. The bricks were molded, a typical brick manufacturing process in the second half of the 19th century.

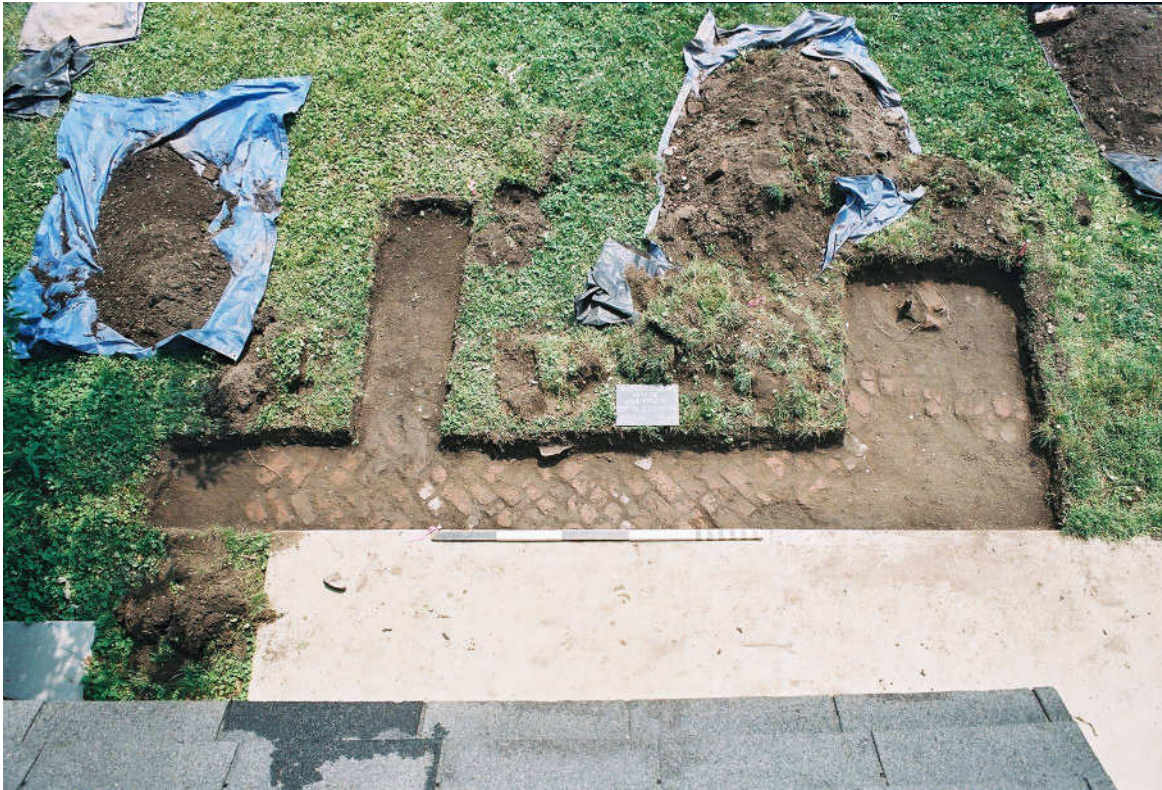
Photo 11. View east of Feature 1 in Units 5 and 12 and STs 6, 8, and 9 from the second floor back porch on 352 Eighth Street.

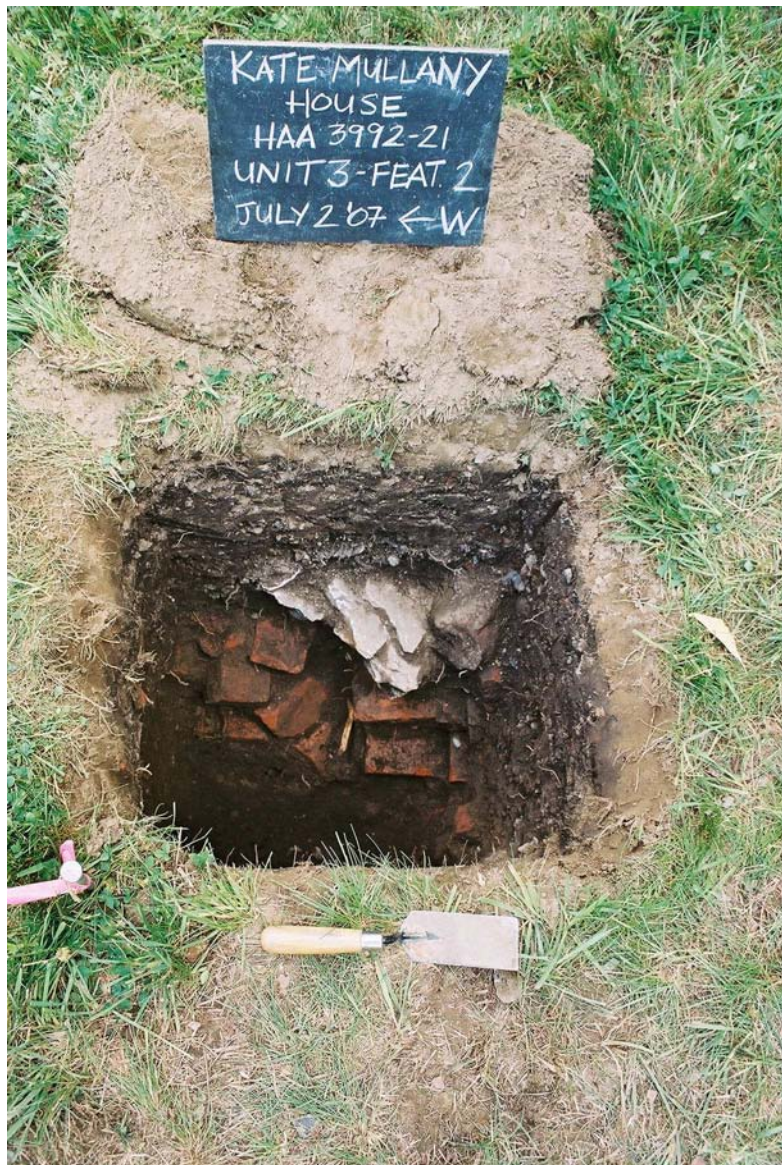
Photo 12. View north of Feature 2 in Unit 3. It consisted of a layer of partially articulated bricks overlaid with fieldstones in the northwest corner of the 50 by 50 cm (19.6 by 19.6 inches) unit.

Unit 3 encountered 10-cm (3.9 inch) thick layer of dark yellowish brown fine sand. The second layer was 38 cm (15.0 inches) of very dark gray loamy sand with glass, nails, ceramic sherds, coal ash, and brick fragments. The remains of a stone and brick foundation (Feature 2) were encountered about 48 cm (18.9 inches) below ground in the north half of Level 3 in Unit 3. A portion of partially articulated brick wall capped with stone was in the northeast corner of the unit. The northwest corner of the unit was disarticulated bricks. The soil in Level 3 consisted of dark brown loamy sand with faunal shell and bone, glass, ceramics, metal, coal ash, and brick fragments. The bottom level was dark yellowish brown sand mottled with very dark brown loamy sand to a final depth of 84 cm (33.1 inches) below ground surface.

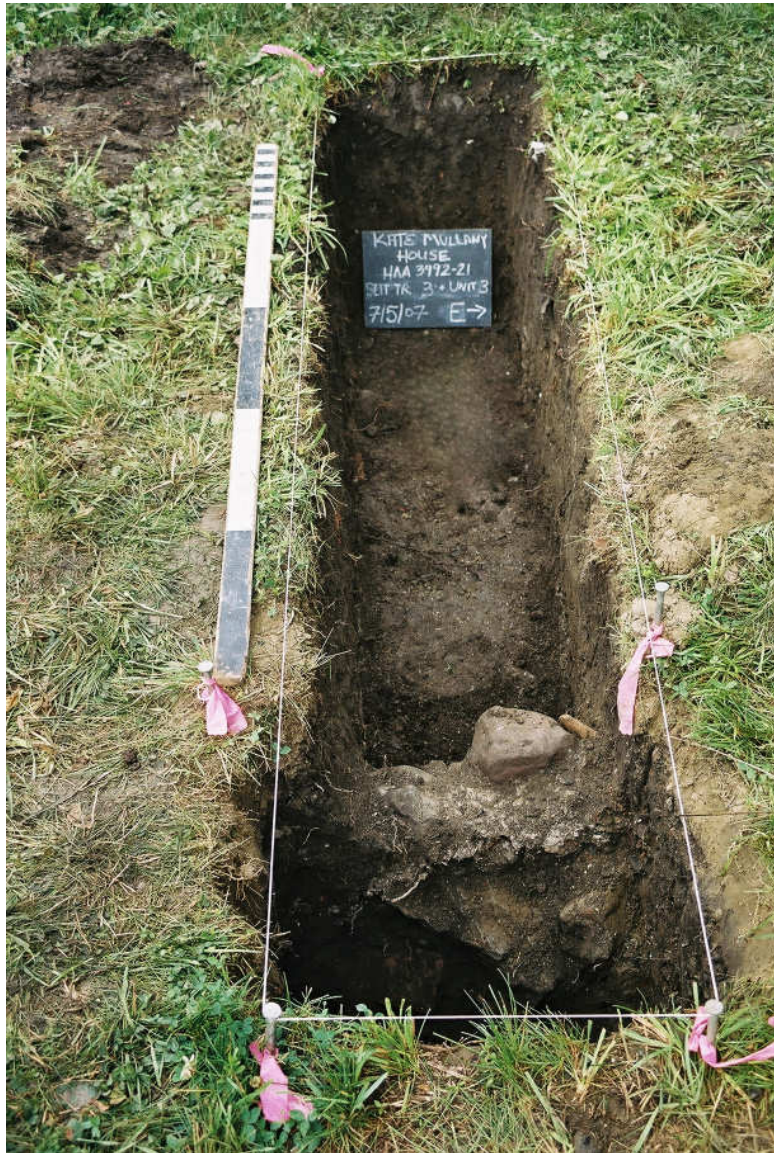
Photo 13. View north of ST 3 and Feature 2. Unit 3 is at the south end of ST 3.

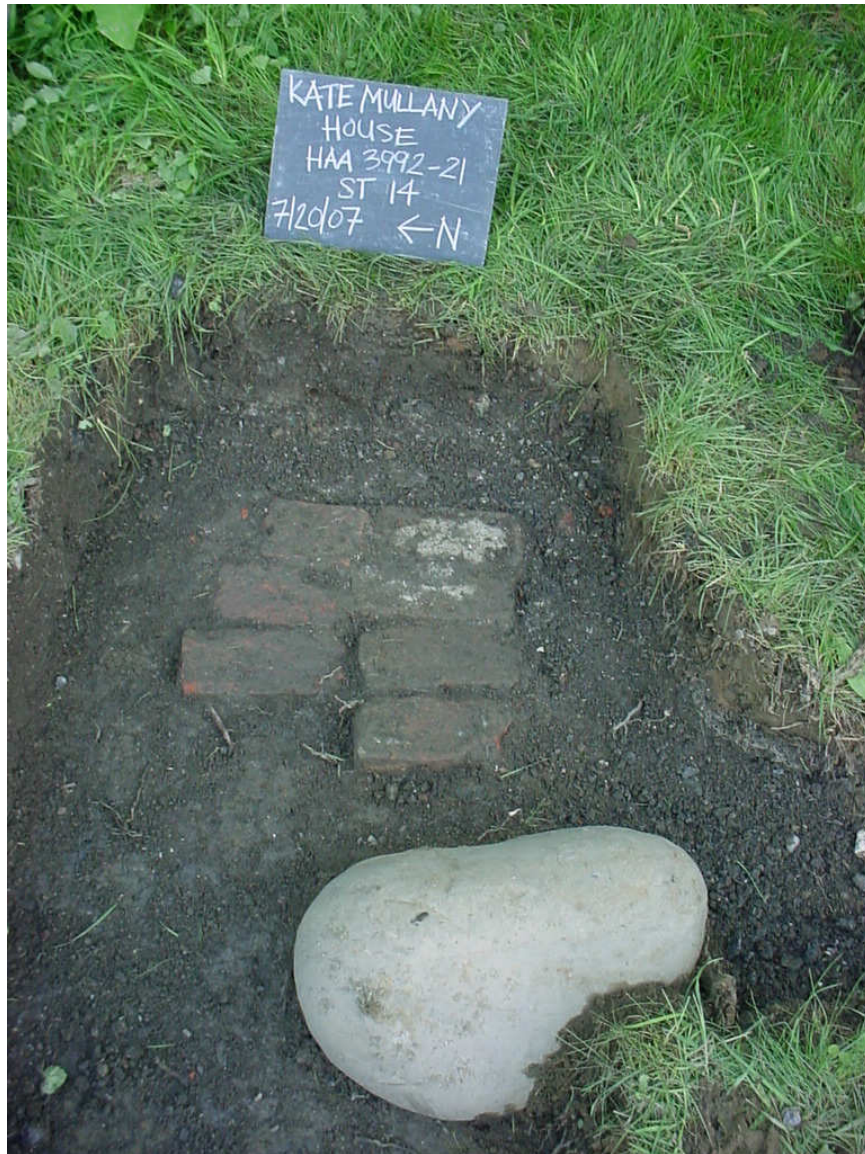
Photo 14. View east of the east end of ST 14 and Feature 5, which is possibly a pier support for a pole shed or other outbuilding.

inches) and 10 cm (4 inches) wide also lay immediately southwest of the pier. It was noted because no other large cobbles of this size were encountered in the yard and it is likely to have been brought and placed here.

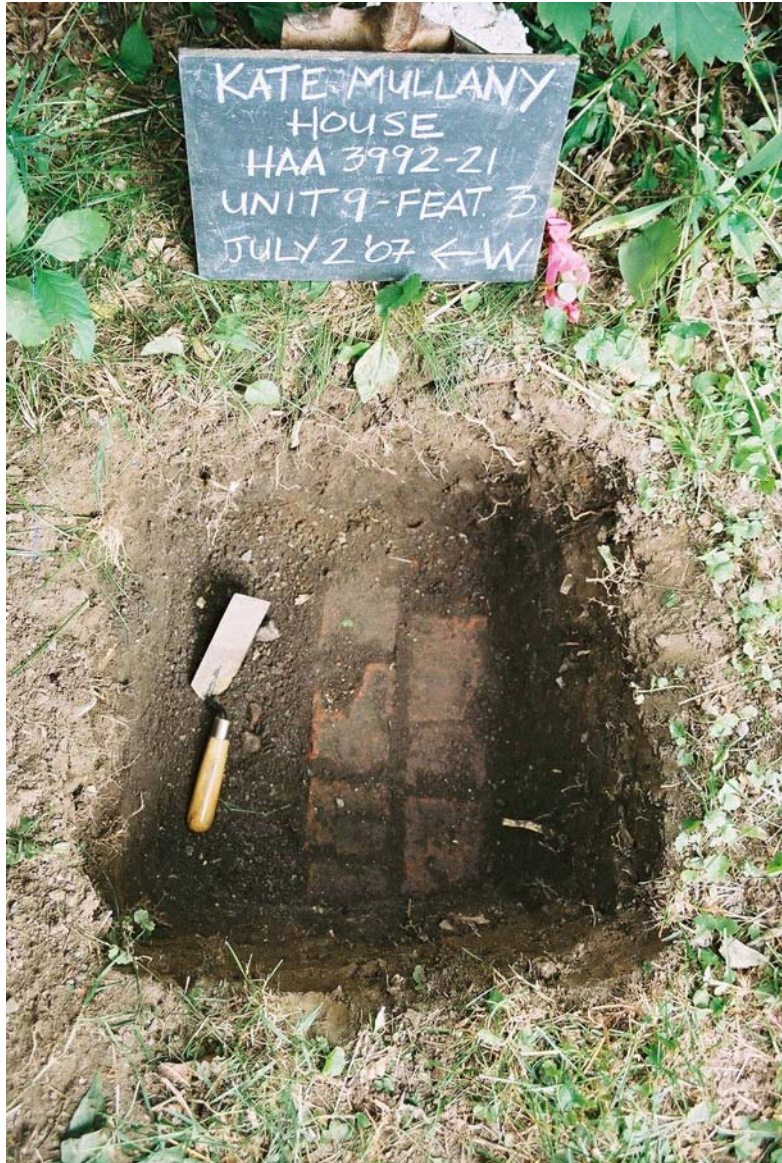
Photo 15. View north of a portion of the brick paving behind 352 Eighth Street (Feature 3) in Unit 9.

Excavation revealed that Feature 3 was two horizontal layers of bricks. The bottom layer was comprised of broken and whole molded bricks of varying sizes laid flat on their broad sides. The bottom layer in ST 12 (Photo 17) was laid in a pattern similar to a herringbone pattern. However, the lower course in Unit 9 and STs 10 and 11 appeared to be laid in a running and stack bond (bricks laid end to end in overlapping, parallel rows alternating with rows of bricks laid side to side). A second layer of bricks was encountered on top of the bottom layer in ST 10, 11, and 12. The top layer consisted of modern extruded bricks (characterized by a larger size than earlier molded bricks; crisp, angular edges; and holes [Photo 17]). Extruded bricks began being manufactured in the early 20th century. It is the dominant brick manufacturing process used today. These extruded bricks were also laid in a stack bond pattern.

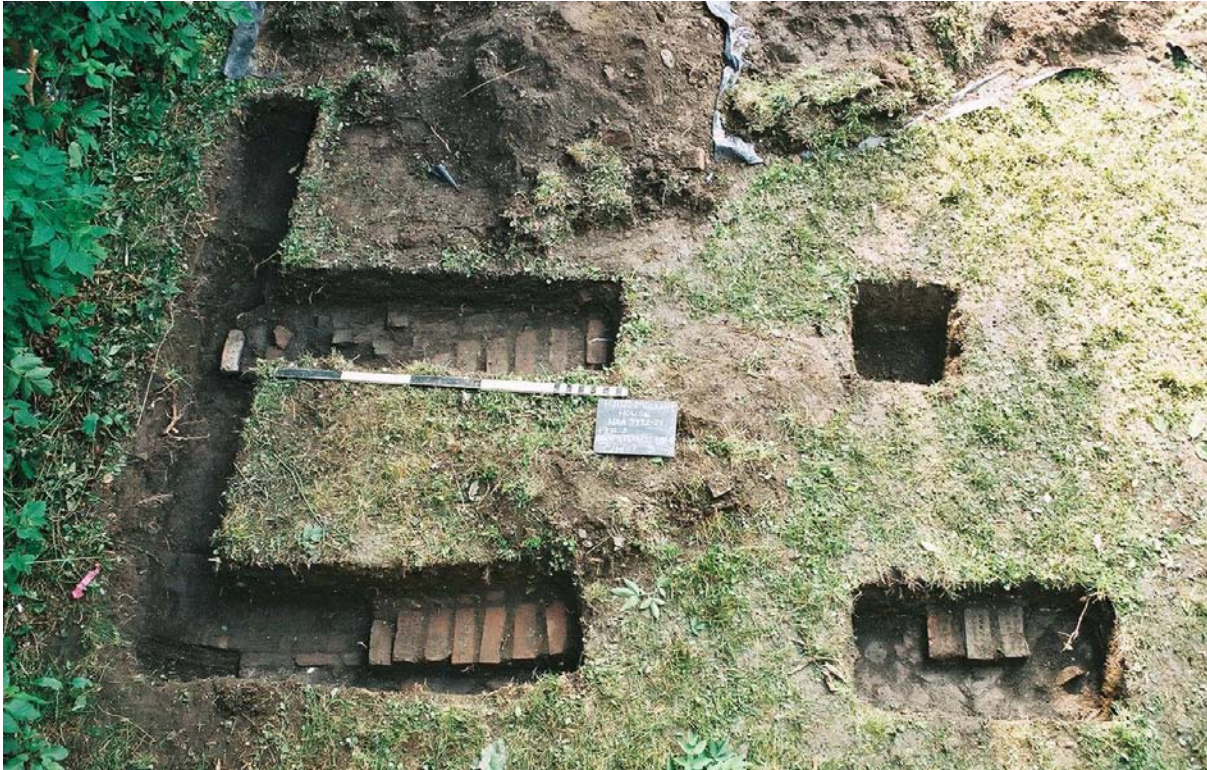
Photo 16. View west of Feature 3 in STs 7, 10, 11, 12, and 13 and Units 9, 13, 14, and 15 from the second-story back porch on 350 Eighth Street. A second top layer of bricks was encountered in STs 10 and 12. The bottom layer of bricks was uncovered in STs 7, 10, 11, 12, 13 and Units 9, 13, 14, and 15.

No mortar was encountered between any of the bricks. The bricks were exposed to the natural elements for some length of time in the past since the surface of the bricks was weathered and frost action may have displaced some of the bricks. The bottom layer of bricks was dry-laid into the soil sometime in the late 19th century. The top layer of brick may have been a laid sometime in the early 20th century to replace the bottom layer which had deteriorated.

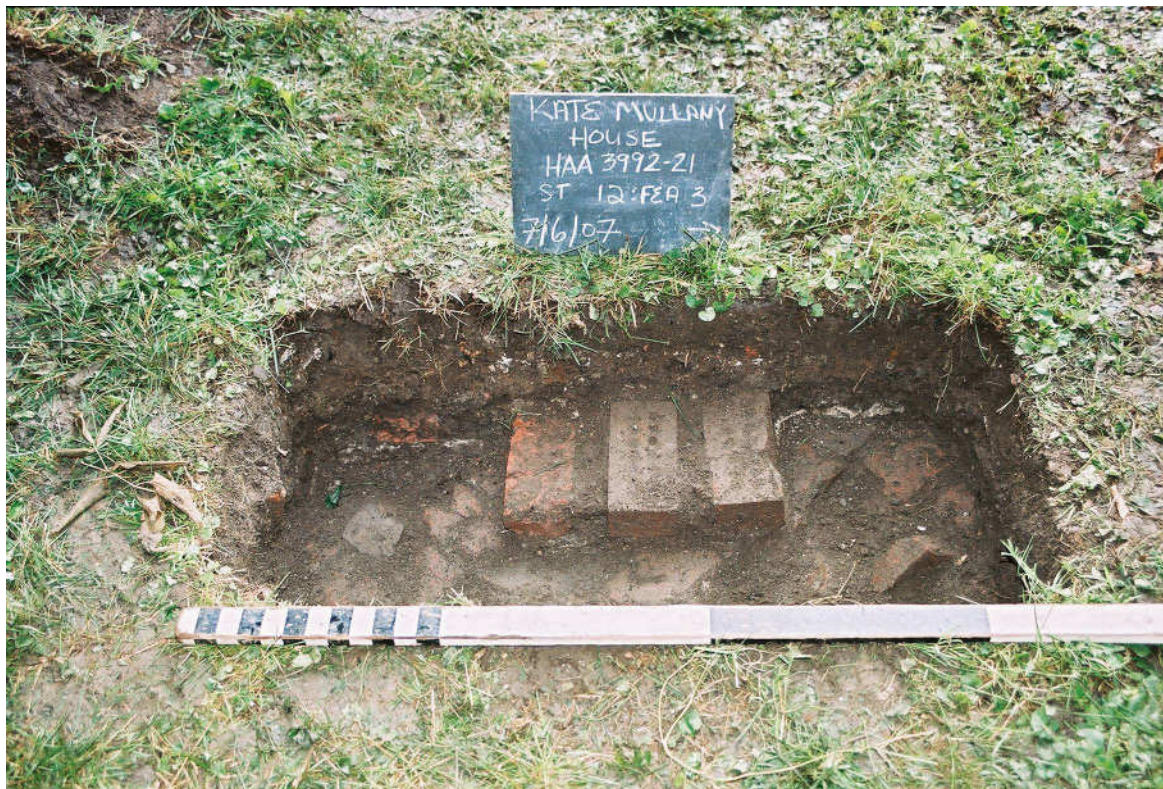
Photo 17. View east of Feature 3 in ST 12 showing the two layers of bricks. The top layer of three parallel bricks in the middle of the ST is modern extruded brick, as indicated by the rows of holes down the center of each brick. The bottom layer consists of historic molded bricks laid in a pattern similar to a herringbone pattern.

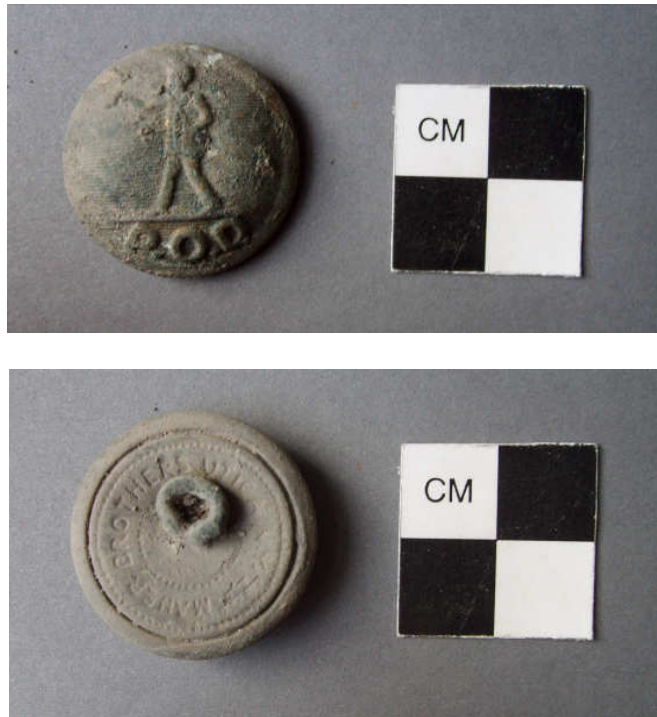
Photo 18. A brass button recovered from ST 7 in the level overlying Feature 3. This style button was used on the uniforms of United States Post Office Department ("P.O.D.") city letter carriers from 1893-1942. The Maher Brothers in Utica, New York manufactured this button.

Artifacts uncovered from the soil overlying Feature 3 included mostly architectural items such as nails and window glass and whiteware ceramic sherds (Table 6). Other artifacts such as food remains, domestic hardware, and glass bottle fragments were recovered. A small number of personal items such as buttons, tobacco pipe stems, and toys were also recovered. One of the buttons was a brass button imprinted with "P.O.D." and a uniformed letter carrier holding a letter on the front and the manufacturers "MAHER BROTHERS UTICA NY" on the back (Photo 18). The United States Post Office Department (P.O.D.) issued this button to its city delivery letter carriers between the years 1893 and 1942. After 1942, the same button continued to be manufactured, but regulations stated that it was to be made of bluish-gray plastic due to war-time metal shortages (USPS 2007). The "P.O.D" button also indicates that the soil overlying Feature 3 covered over the brick patio between 1893 and 1942.

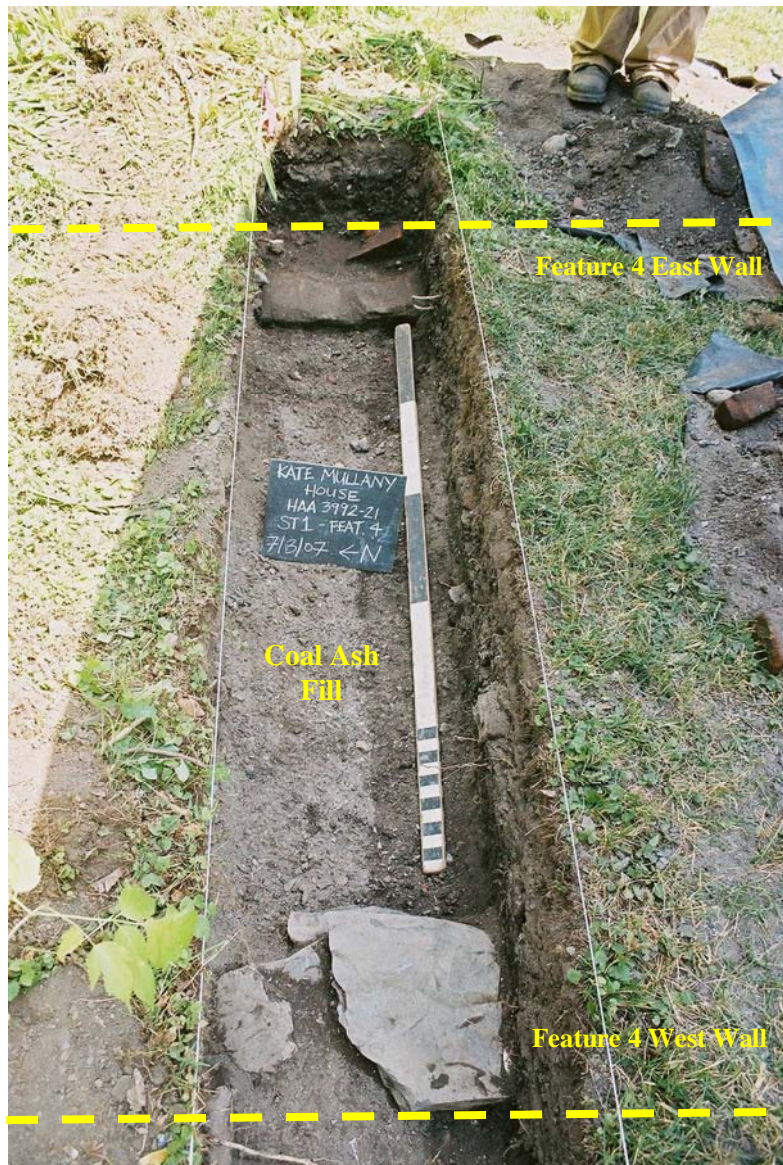
Photo 19. View east of ST 1 and the top of the east and west foundation walls of Feature 3. The west wall appears to be mortared-stone. The east wall is mortared-stone topped with brick. The privy vault is the gray soil with coal ash in between the foundations. The scale stick is 5 feet (1.5 m) long with inches indicated at the closer end.

The first layer of soil in this trench consisted of very dark grayish brown loamy sand with gravel. Artifact including ceramic sherds, glass fragments, marbles, nails, and a turtle shell were encountered. Two sections of stone foundation were identified in ST 1. The western foundation was about 2.5 m (8.2 ft) from the west end of the trench, about 16 cm (6.3 inches) below ground surface, and about 30 cm (12 inches) wide. The eastern foundation was about 20 cm (8 inches) from the east end of ST 1, about 15 cm (6 inches) below ground surface, and about 20 cm (8 inches) wide (Photo 19). The soil between the foundations consisted of grayish brown coal ash with cultural material including ceramic sherds, nails, glass vessel fragments, white clay tobacco pipes, a copper alloy cross, and carbon rod from a carbon arc street lamp. The soil outside of the foundation walls, in the east and west ends of the trench, consisted of very dark grayish brown sandy loam. The two foundations were enclosing a deposit that differed from the surround matrix, which is very likely the privy vault.

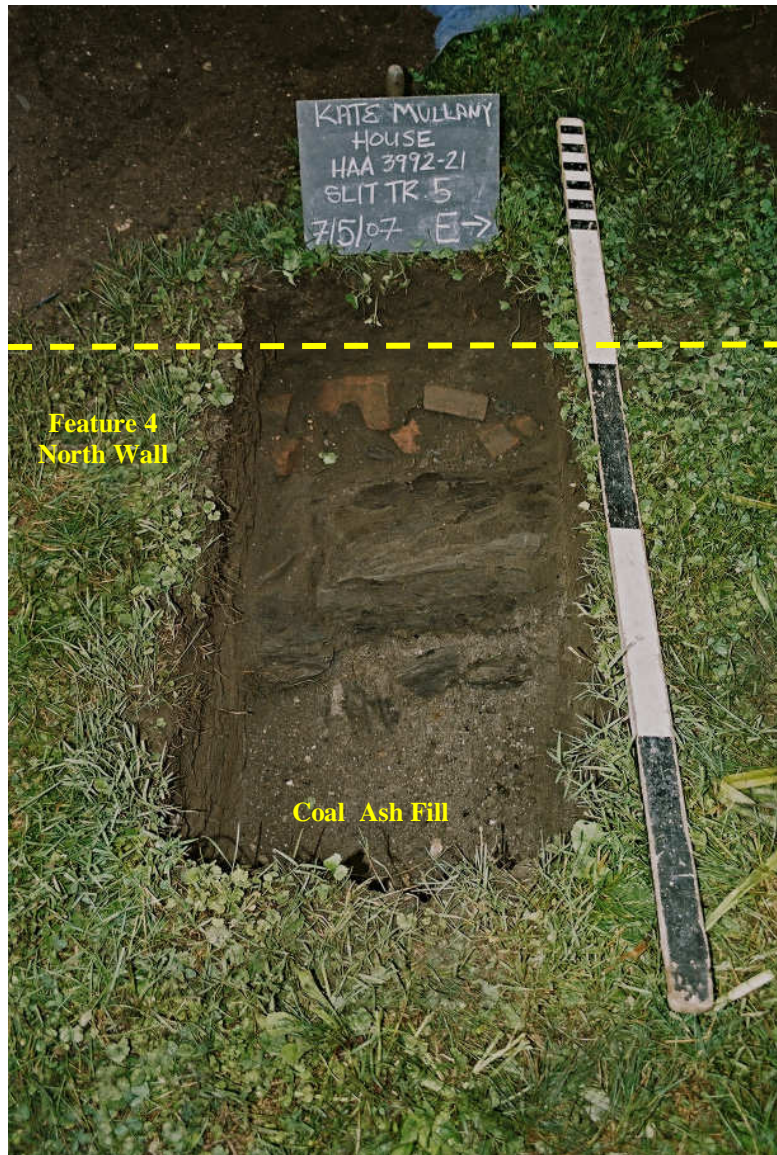
Photo 21. View north of ST 5 and the north foundation wall of the late 19th century privy (Feature 4). This wall was also mortared-stone topped with bricks. The grayish brown soil with coal ash in the south end of the trench is the privy vault fill.

The 1903 Sanborn indicated that the outbuilding was about 10 feet (3 m) long. Therefore, ST 5 was placed about 1.5 m (5 ft) north of ST 1, also about 10 feet (3 m) north of the foundation in ST 4. The grayish brown coal ash was uncovered in the south end of ST 5 and the stone foundation was uncovered at the north end of the trench

(Photo 21). The foundation was 15 cm (6 inches) south of the north end the trench and was about 40 cm (16 inches) wide. The top of the foundation was about 15 cm (6 inches) below ground surface.

The four sections of foundation uncovered in STs 1, 4, and 5 are all associated with a single rectangular foundation (Feature 4). The same coal ash deposit was encountered inside the foundation segments in STs 1, 4, and 5 the foundation. Feature 4 does not align exactly with the outbuilding shown on the 1903 map. The location of the outbuilding on Sanborn map may not be precise. Feature 4 does align with the approximate location of the geophysical anomaly identified in the middle of the yard. The anomaly covers in the northern portion of the feature and may be more representative of disturbance from a large bush growing in this location, as documented in the NPS report.
