PHASE I ARCHEOLOGICAL INVESTIGATION
PROPOSED KATE MULLANY PARK
KATE MULLANY HOUSE NATIONAL HISTORIC SITE
(98NR01334)
350 EIGHTH STREET
CITY OF TROY
RENSSELAER COUNTY, NEW YORK

HAA 3992-21
OPRHP 06PR00447

JANUARY 2008

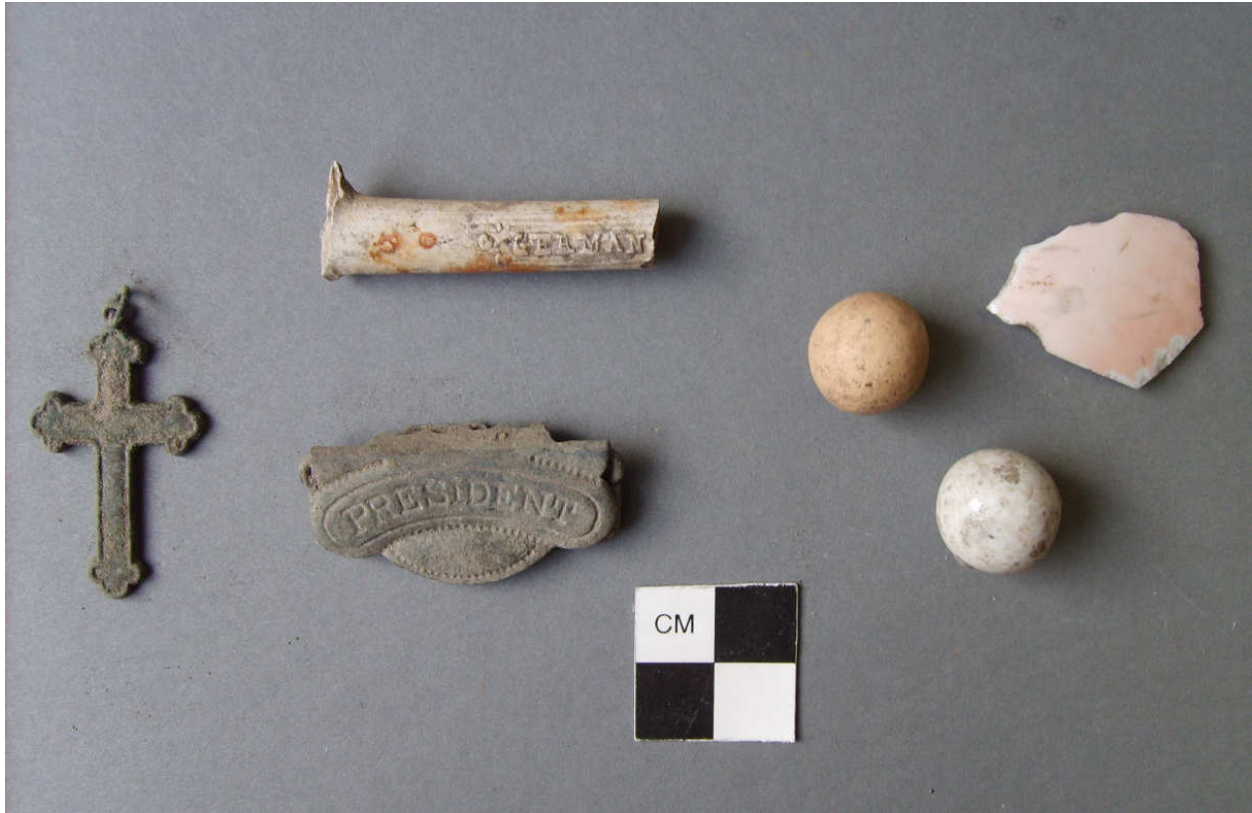
Photo 22. A few of the personal items recovered from the second level of ST 1, which was the top of the coal ash fill in Feature 4. Clockwise from the top of the photo the artifacts in this photo include a white clay tobacco pipe stem marked "GERMAN" ([Bag]23:[Item]34), an unglazed ceramic toy marble (23:45), a porcelain doll fragment (23:44), a white glazed ceramic toy marble (23:46), a metal suspender clasp from the President Suspender Company (23:49), and a brass cross necklace charm (23:50). The artifacts from this context all dated from around the turn of the 19th century.

The artifacts associated with Feature 4 from ST 1, 4, and 5 were recovered from the coal ash fill inside the foundation, which was the surface of the privy vault (Table 7). The artifacts consisted mostly of undecorated whiteware sherds, nails, faunal bone fragments, and glass bottle fragments. A handful of personal items including buttons, white clay tobacco pipe stems, a President Suspender Company suspender buckle, and toy marbles, were also recovered (Photo 22). The President Suspender Company, from Shirley, Massachusetts was established around 1900 (Shirley Historical Society 2007). A 1971 United States penny was recovered from Level 2 of ST 5. This was the only modern artifact recovered from this area. A number of artifacts dated no earlier than around the turn of the 19th century, including the President suspender buckle (c. 1900), machine molded bottles (c. 1899), and an asphalt roofing shingle (c. 1903). Therefore, it is likely that this privy vault was put out of use and filled sometime shortly after the turn of the century.

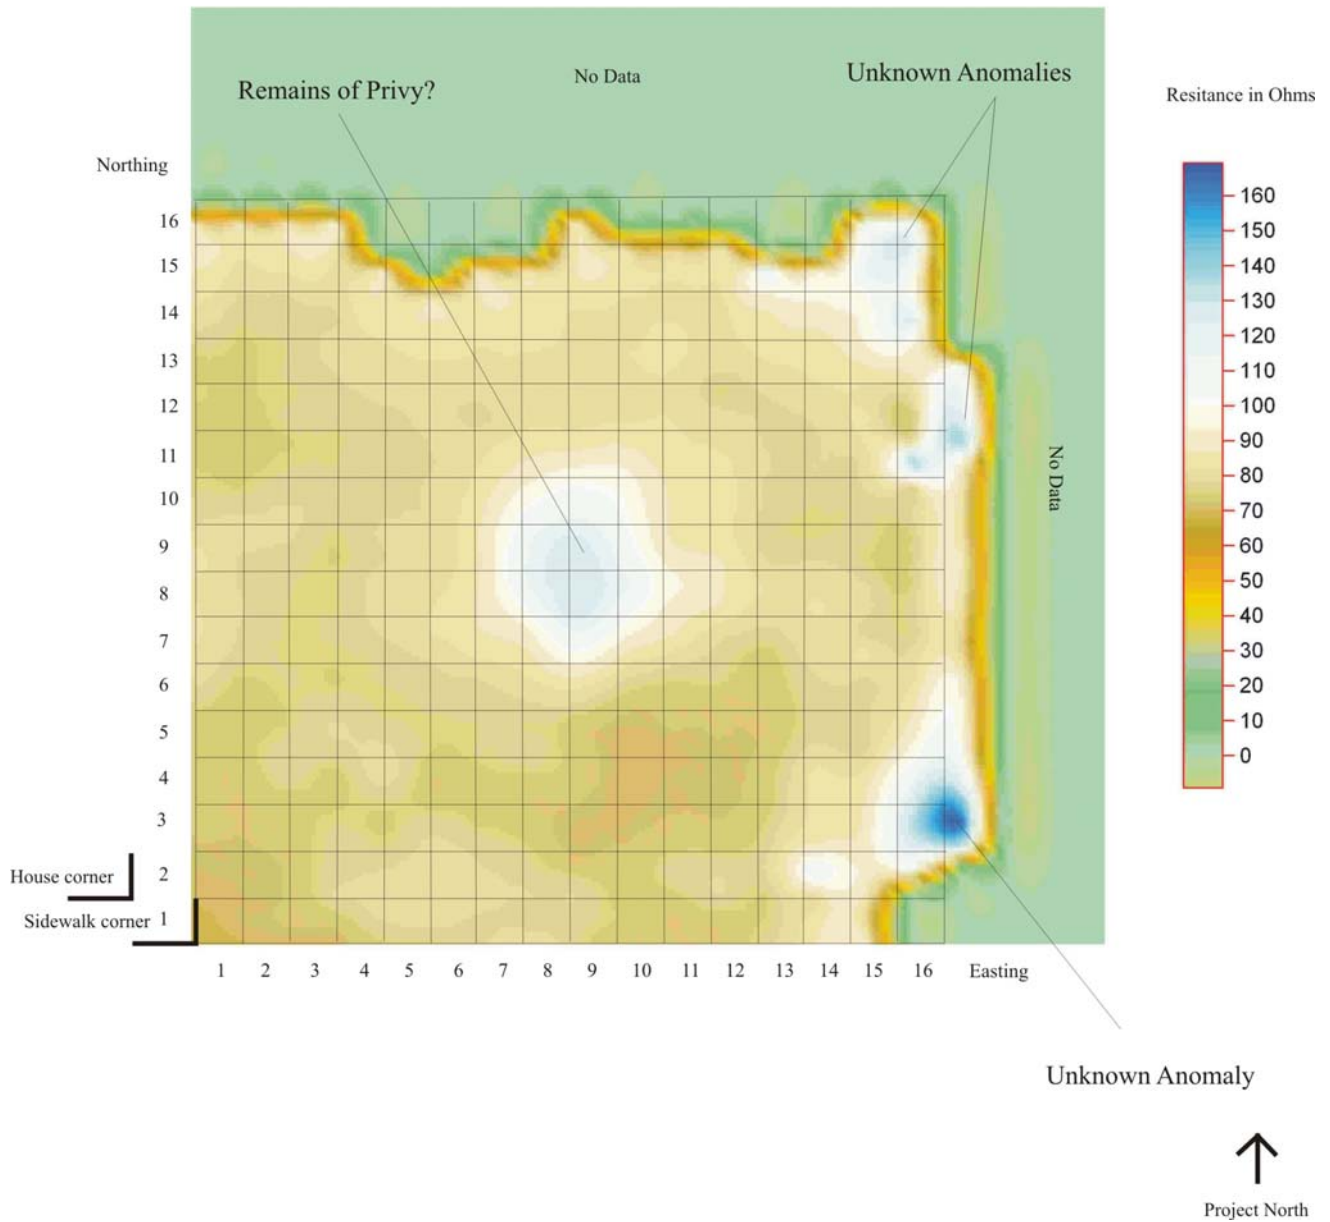
Figure 3 Map of Resistance Readings.

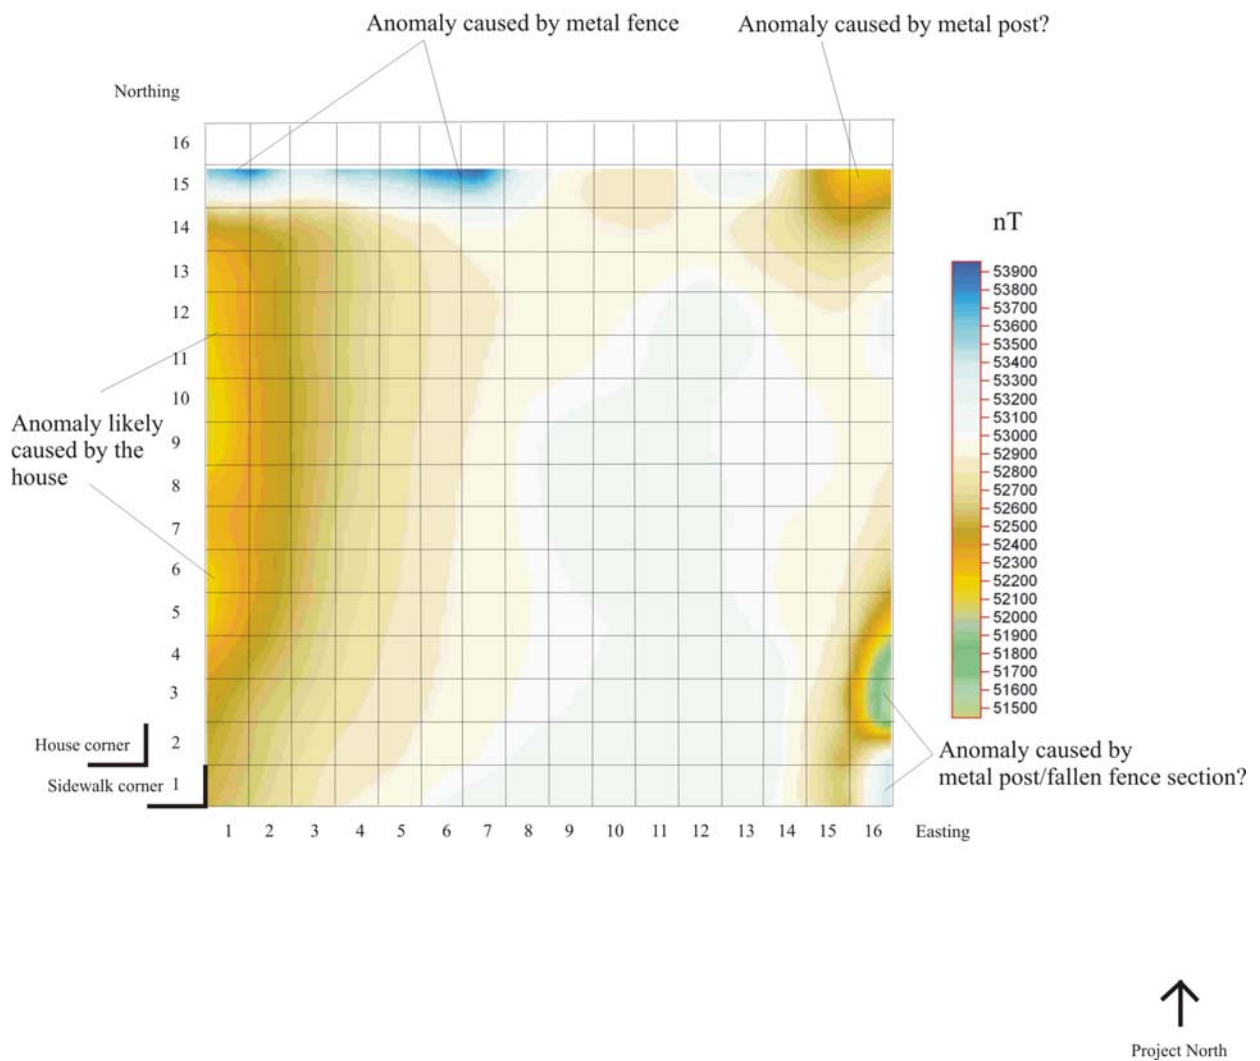
Figure 4 Map of Magnetic Readings

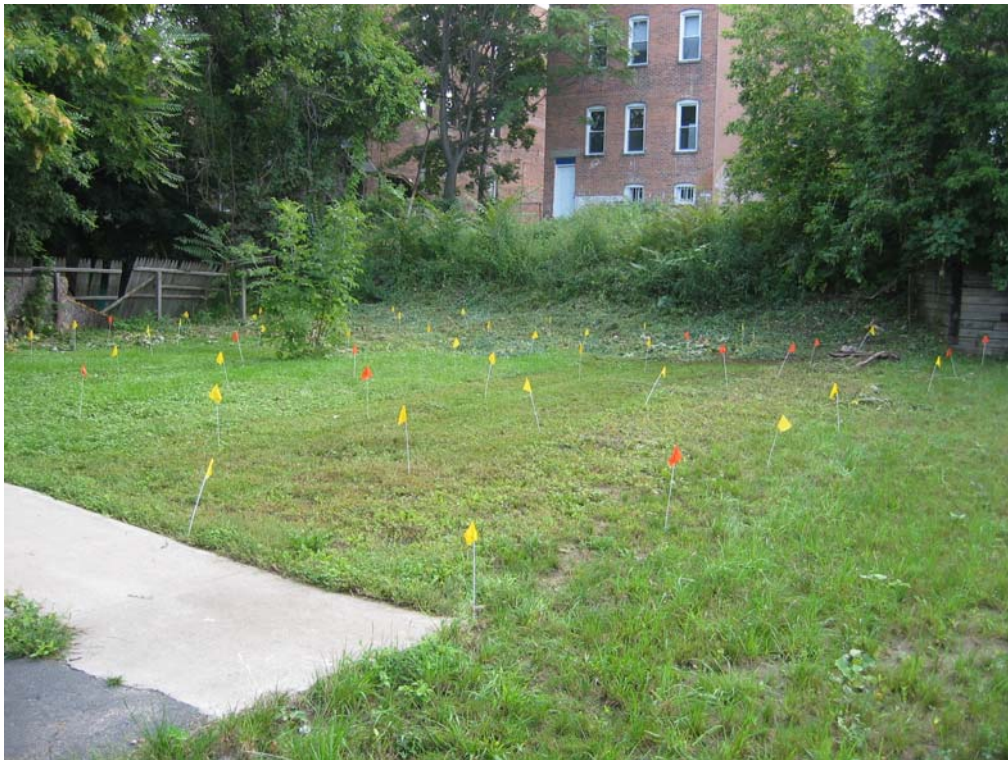
Figure 7 Photograph looking northeast across the grid.

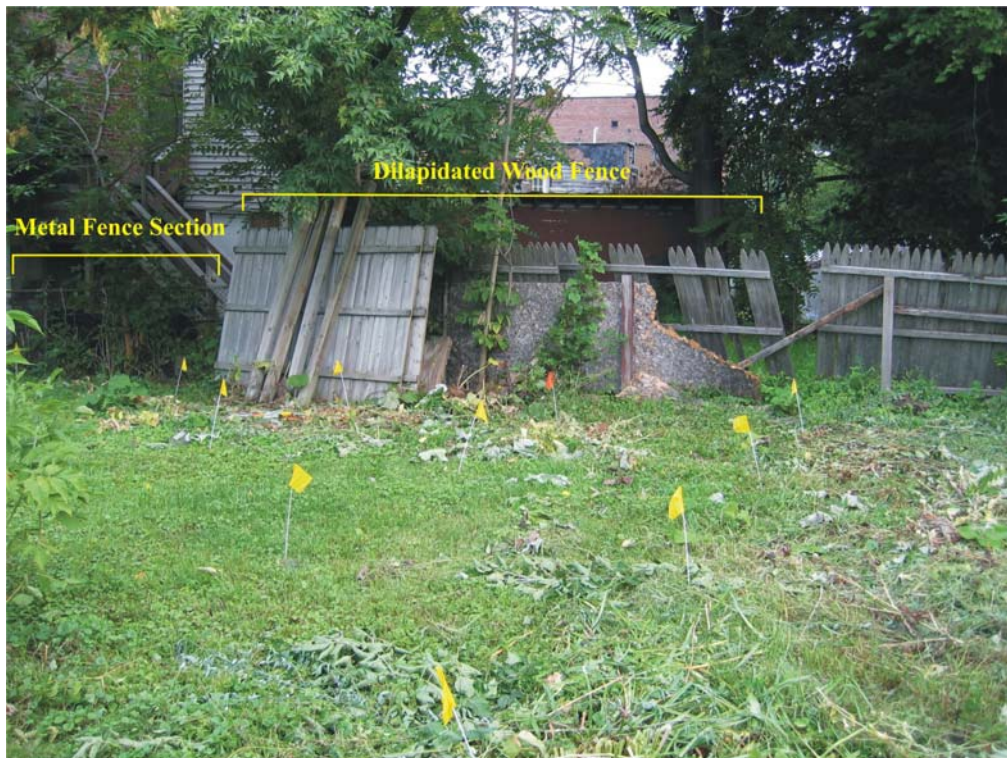
Figure 8 Photograph looking north at the fence at the northern portion of the grid.

Several anomalies can likewise be seen in the magnetics data for Grid 1 (Figure 4), but may or may not pertain to archeological resources. The large anomaly to the western portion of the grid is likely related to the proximity of the house to the grid. Two large air conditioners are located between the grid and the house and could account for the anomaly. The high intensity magnetic reading along the northern edge of the grid is likely due to the close proximity of the metal fence. The anomalies correspond rather well with the location of the various fence sections (Figure 8).

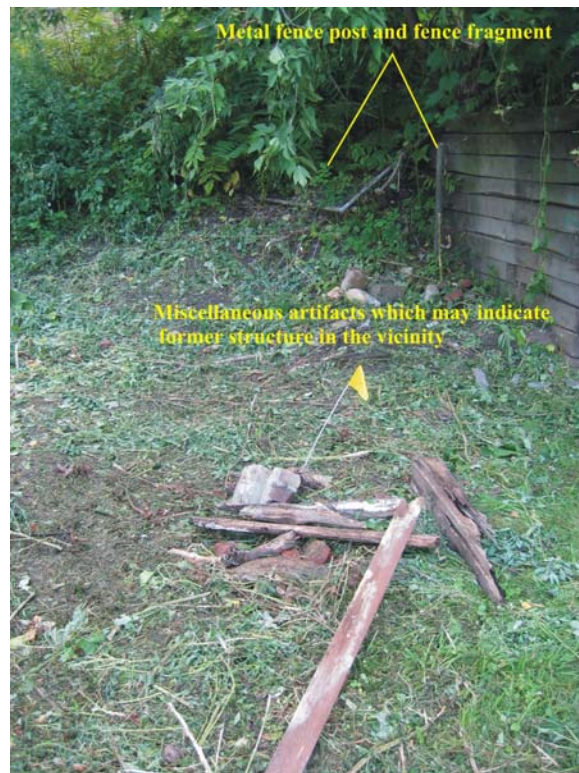
Figure 9 Photograph of southeast corner of the grid.

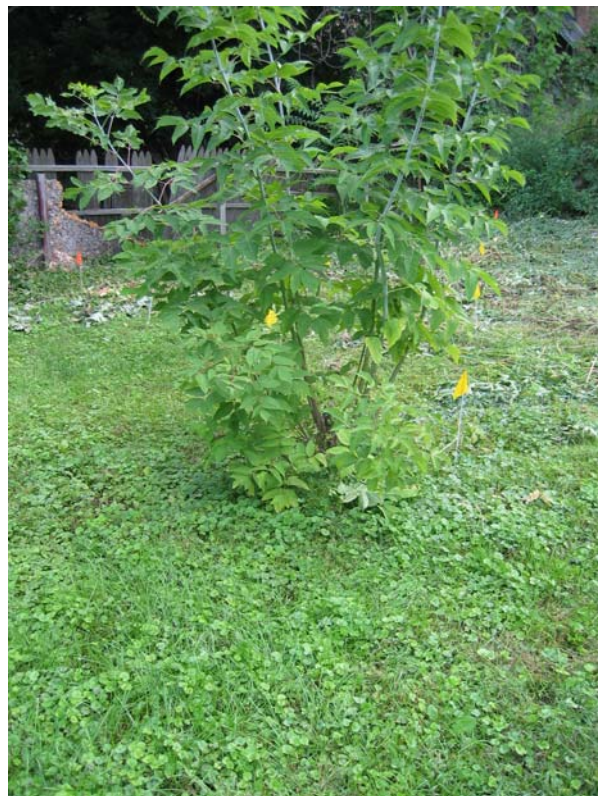
Figure 10 Photograph of vegetation growing in/near the former privy

Grading around backyard should not be done. The remains of the privy should be protected from any developmental impact. Limited archeological investigations on the privy will provide information concerning its construction and research potential. Privies are like time-capsules. After they go out of service, people fill them up with period trash. While the likely filling date for the privy was after Kate Mullany's occupation of the house, the deposits may nevertheless be important archeological resources. Something should be done on the surface of the ground to interpret the privy to the public. Since there is currently a depression around the vegetation that is growing in/near the privy (Figure 10), the vegetation should be flush-cut and the privy filled to the level of the surrounding yard with clean fill. The tree along the back foundation should also be flush cut.
